MANAGING CARPENTER ANT POPULATIONS IN URBAN ENVIRONMENTS

L. D. HANSEN

Biology Department, Spokane Falls Community College, 3410 W. Fort George Wright Drive,
Spokane, WA 99204, U.S.A.

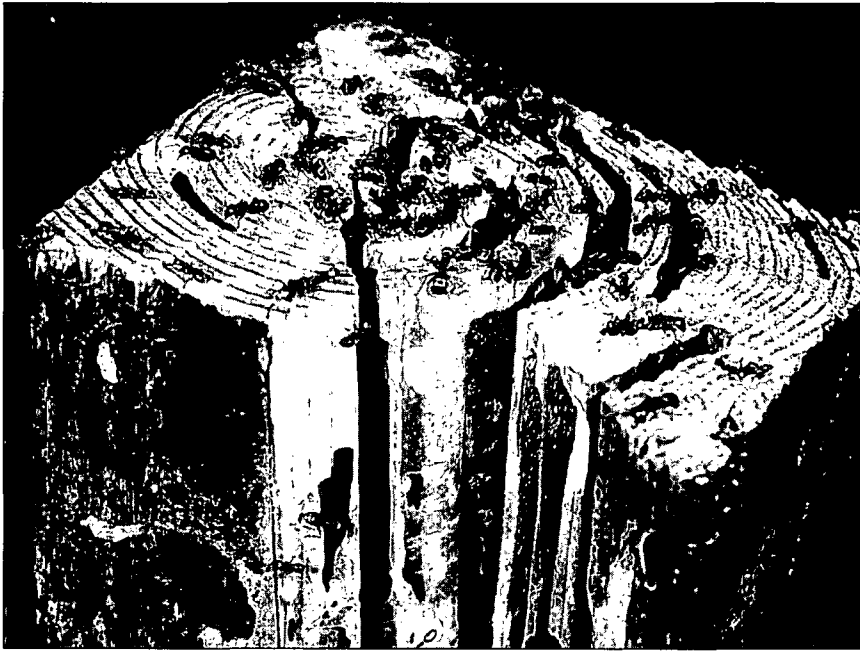
Figure 1. Structural beam infested with *Camponotus modoc*.

Carpenter ants have long been recognized as structurally damaging in the northern United States, Canada, and northern Europe (Hansen and Akre, 1990; Wallin and Schroeder, 1994) (Fig. 1). In many other parts of North America and Europe, carpenter ants are classified as nuisance pests. The categorization of either nuisance or structurally damaging is dependent, in part, upon the species involved (Hansen and Akre, 1994; Hansen, 1995). A total of 23 species of *Camponotus* has been recorded in North America invading structures in one of these categories. Some of these species attack only decayed wood; others will attack sound wood. Nests are made in standing and downed timber, in stumps, and in wood used in structures. Tunneling by carpenter ants was reported in 75% of the ornamental trees in urban environments in the state of New Jersey where the tunneling weakened the trees physically and exposed them to other pests and pathogens (Fowler and Parrish, 1982). Due to these nesting activities, carpenter ants have become a major economic problem in urban environments.

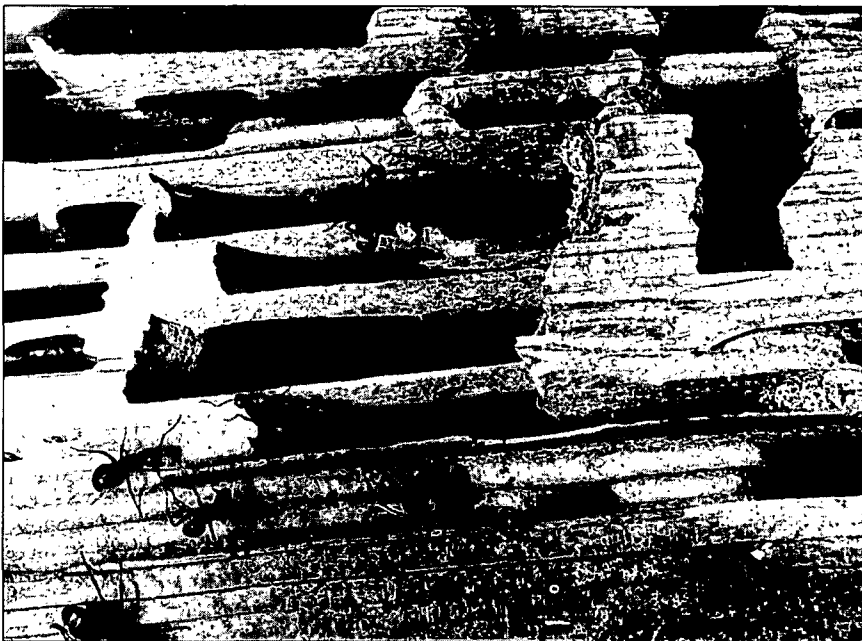
Figure 2. Carpenter ant infestation showing galleries and runways.

Unlike termites, which have symbiotic microorganisms in their midgut to aid them in the digestion of cellulose, carpenter ants do not ingest wood. Instead, they remove wood with their mandibles to excavate brood chambers from the wood matrix and then deposit these wood chips away from their galleries and runways (Fig. 2).

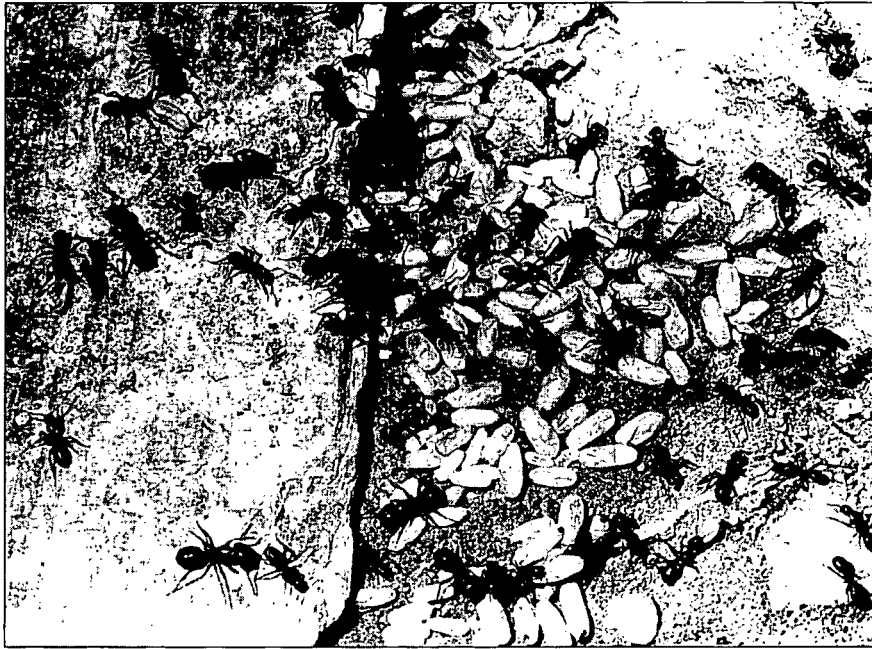
Figure 4. Satellite nesting site of *Camponotus modoc* under a piece of wood used in landscaping.

The exterior of the structure was inspected for wood in contact with soil (Fig. 4) and other areas with moisture problems. Common problems occurred with gutters, roofs, and exterior framing of windows and doors. Tree branches or shrubs touching the exterior of the structure or the roof provided foraging trails for the ants. Wood timbers and other wooden structures used for decoration or landscaping were carefully inspected by listening for hollow sounds when the timber was tapped. Timbers that sounded hollow were removed. In infested timbers, carpenter ants were tunneling underground away from the timber, lining their tunnel with wood fragments from the timber, and emerging at a distance of 1–4 m.
