PESTS ASSOCIATED WITH GREEN BUILDING: AN EMERGING INFESTATION IN ITALY

¹DANIELE CALDIROLA, ¹CIRO D'AMICIS, ²PASQUALE MASSARA

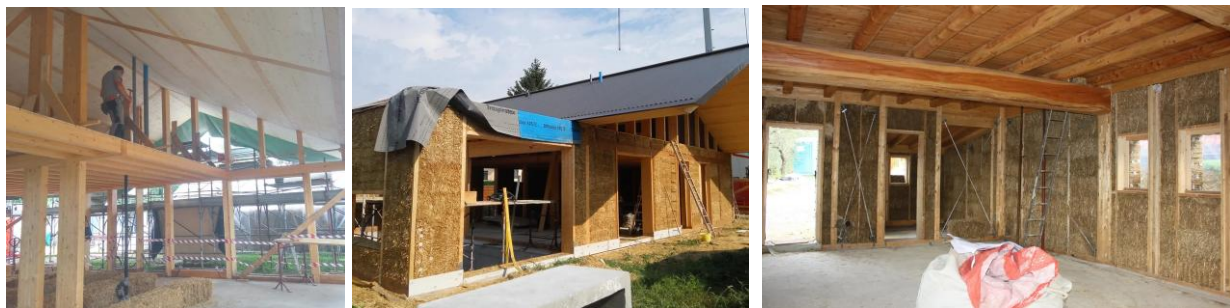
Figure 1-2-3: Example of straw-insulated in green-building.

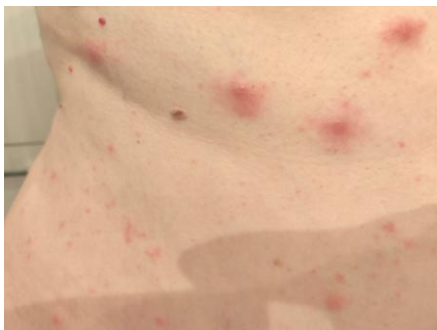
Medical Diagnosis: A dermatologist documented "papular lesions arranged in a linear pattern, consistent with exogenous dermatitis."

Figure 5: Bites on the right side.

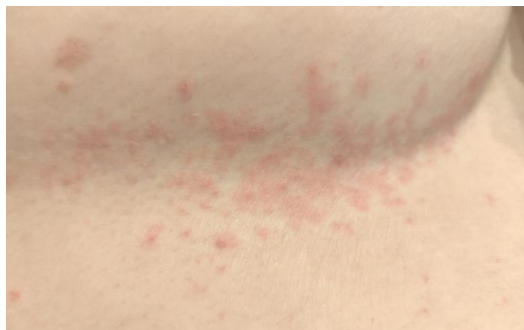
Figure 6: Bites under the left breast.

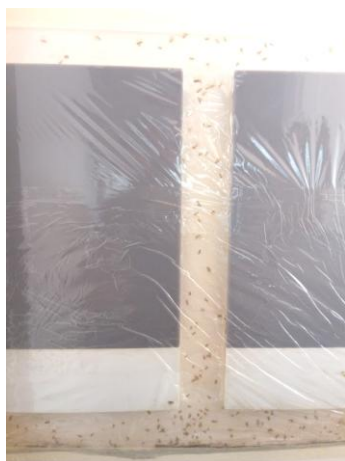
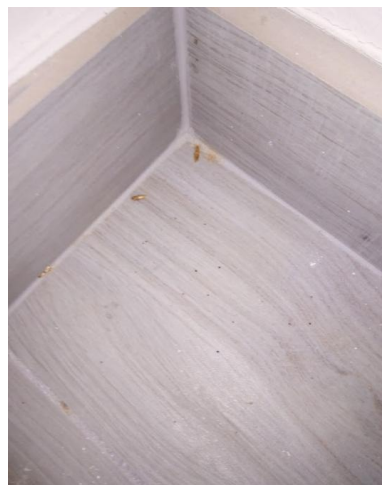
Inspection Findings: All electrical outlets had been temporarily sealed with cellophane and tape by the client. Insulation inspection: sheep wool insulation in all rooms, including the basement garage, showed signs of infestation. External storage area: untreated wool rolls stored outdoors exhibited extensive traces of *Tineola bisselliella* (clothes moth) activity.

Figure 11: *Tineola b.* inside a sealed electrical outlet. **Figure 12:** Specimens found on ground.

To control the infestation and avoid removing the insulation, a heat-treatment strategy was implemented. This involved deploying electric convector heaters in sufficient quantities to raise the ambient temperature to 53°C, targeting all life stages of *Tineola bisselliella* (eggs, larvae, and adults). To evaluate heat distribution within the insulation's outermost layers, temperature probes were installed after drilling access points into the wall.

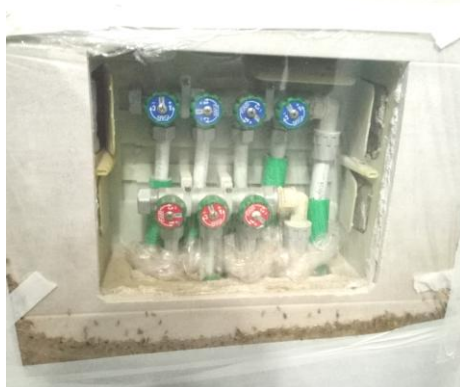
Figure 13: *Tinea bisselliella* trapped in the water conduits.

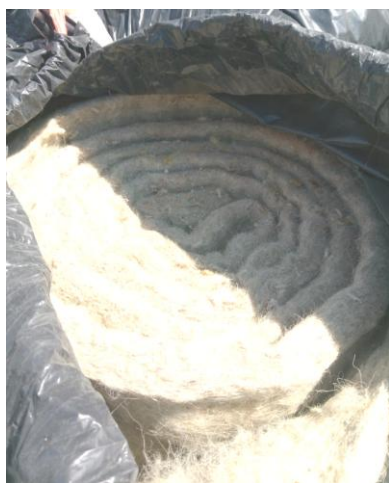
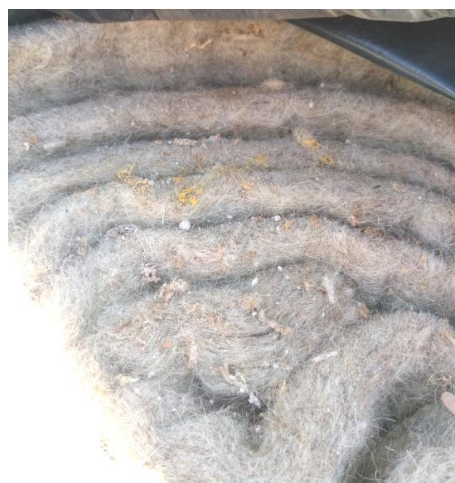
Figure 14-15: Rolls of wool pre-treated showing clear traces of *Tineola bisselliella*.

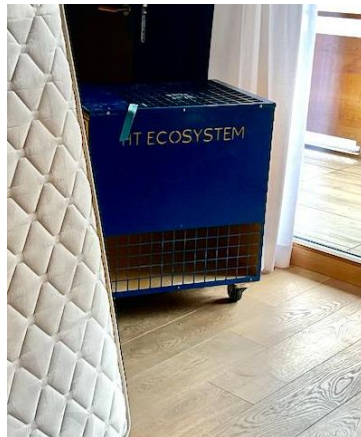
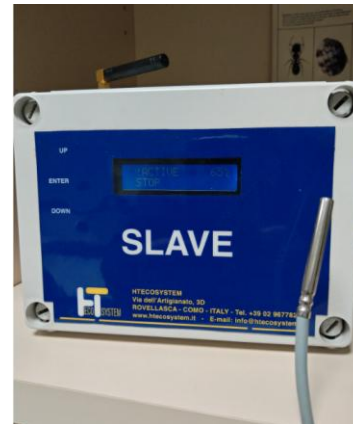
Figure 11: Example of heat machine used. **Figure 12:** Temperature probe sensor

Based on the building's dimensions, 18 heating units were strategically deployed. The treatment's efficacy was significantly impacted by external climatic conditions, particularly unseasonably high temperatures. For instance, cross-referenced data from August 29, 2017, revealed a sharp drop in external temperatures due to a precipitation event (see graph below). To mitigate heat loss and maintain treatment effectiveness, internal temperatures were elevated to 55°C during this period.

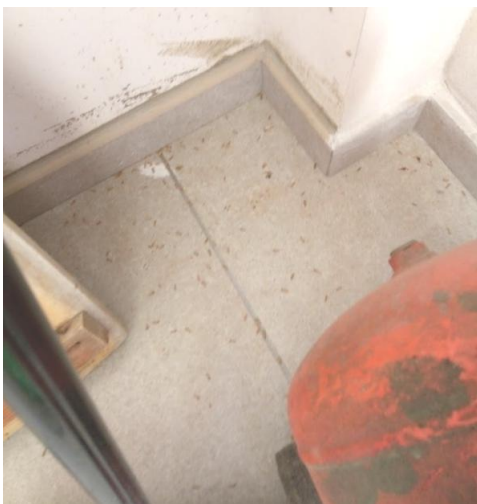
At the end of the treatment, monitoring traps for *Tineola bisselliella* (clothes moths) were set, but no new captures were detected. Seven years after the treatment, the client has not reported any new infestations or sightings of *Tineola bisselliella*.

Figure 16: *Tineola bisselliella* body dead detected post-treatments.
